USAAEFA PROJECT NO. 81-18

**UH-60A LIGHT ICING ENVELOPE EVALUATION  
WITH THE BLADE DEICING KIT INSTALLED  
BUT INOPERATIVE**

**FINAL REPORT**

**JUNE 1982**

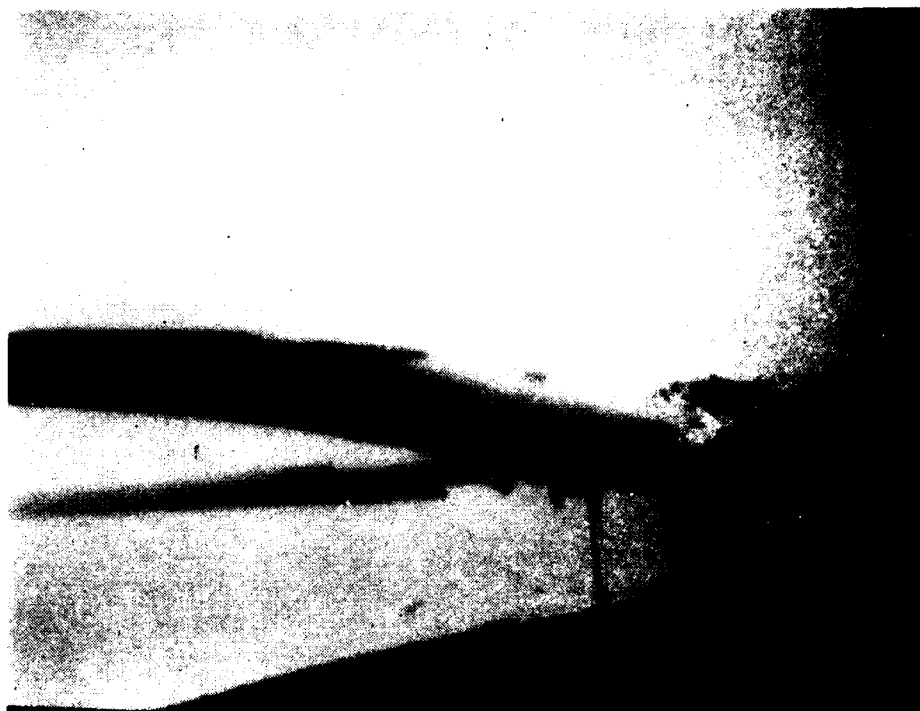
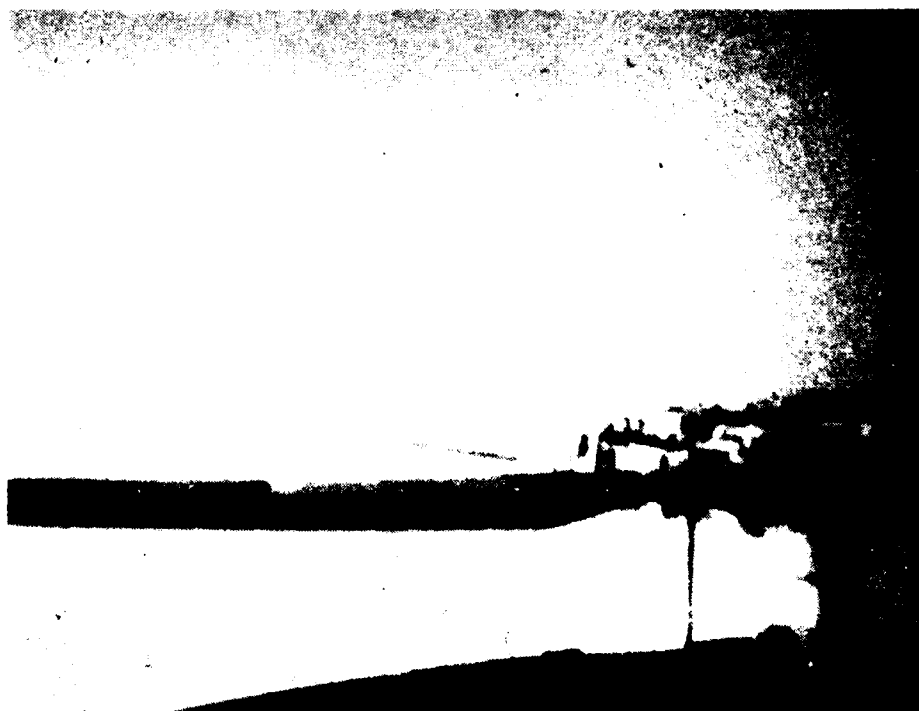
10. Main rotor ice sheds occurred in both the artificial and natural icing environments. The ice accretion and shedding characteristics of the main rotor blades was independent of leading edge surface condition. A typical time history of engine torque rise during rotor system ice accretion in natural icing conditions is presented in figure 3, appendix F. The first ice shed during a flight typically occurred from 17 to 52 minutes after entering the icing environment with random and more frequent sheds occurring thereafter. The time required for the first shed to occur and the frequency of subsequent sheds appeared to be a function of the LWC and ambient outside air temperature. Photos 1 through 5, (app G), taken during flight in artificial icing conditions, and photos 6 and 7 (app G), taken after landing, show representative characteristics of main rotor ice accretion and shedding.

an experienced aircrew fully occupied by their tasks and, on occasion, noticeable only if their attention was directed to it or when not otherwise occupied (Vibration Rating Scale (VRS) 3 to 4). One main rotor ice shed occurred (photos 1 and 2, app G) during artificial icing at  $0.5 \text{ gm/m}^3$  LWC and  $-12.5^\circ\text{C}$  which resulted in an airframe vibration immediately apparent to the aircrew but did not significantly affect their workload over the length of time the vibration lasted (approximately 10 minutes) (VRS 6). Significant airframe damage also occurred from main rotor ice hitting the fuselage during this icing encounter (para 16). The increase in airframe vibrations due to main rotor ice shedding was satisfactory.

Photo 1. Main Rotor Ice Accretion Artificial Icing:  
0.5 gm/m<sup>3</sup> LWC, -12.5° C, 81 Minutes

Photo 2. Main Rotor Ice Accretion Artificial Icing:  
0.5 gm/m<sup>3</sup> LWC, -12.5°C, 81 minutes

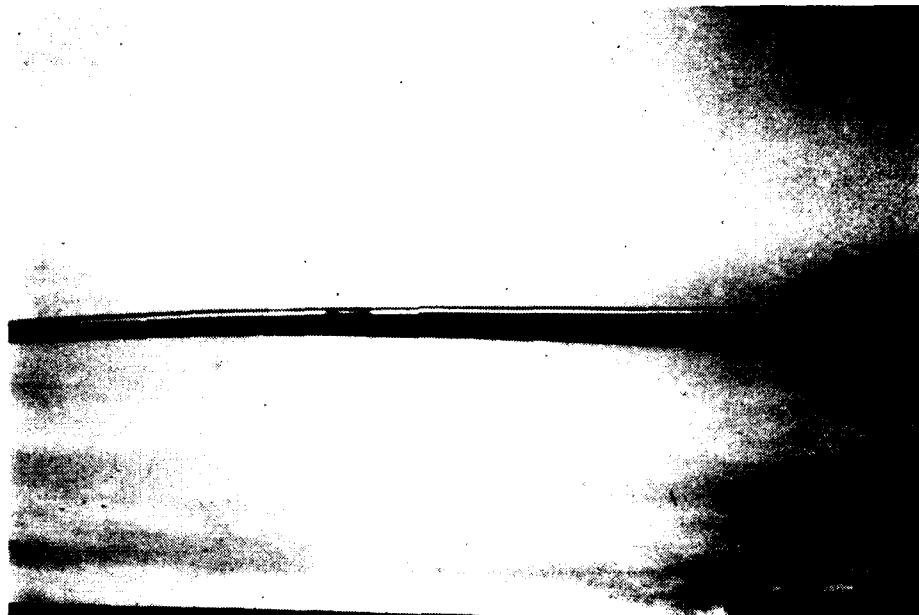
Photo 3. Main Rotor Ice Accretion Artificial Icing:  
0.21 gm/m<sup>3</sup> LWC, -17.0° C, 47 Minutes

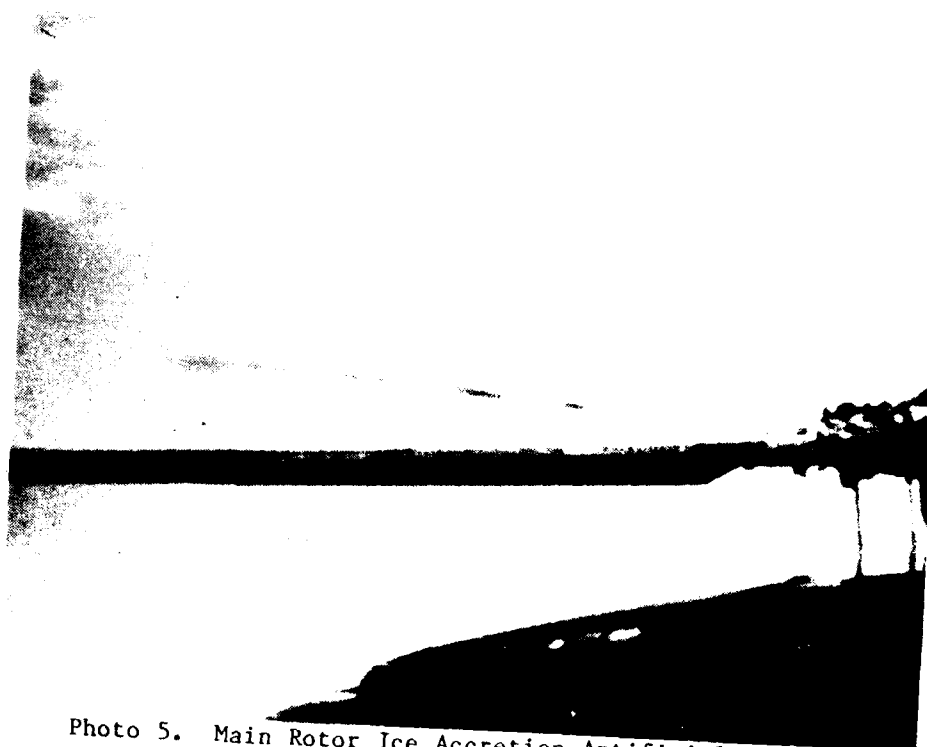
Photo 4. Main Rotor Ice Accretion Artificial Icing:  
0.49 gm/m<sup>3</sup> LWC, -6.0° C, 60 Minutes

Photo 5. Main Rotor Ice Accretion Artificial Icing:  
 $0.49 \text{ gm/m}^3$  LWC,  $-6.0^\circ \text{ C}$ , 60 Minutes

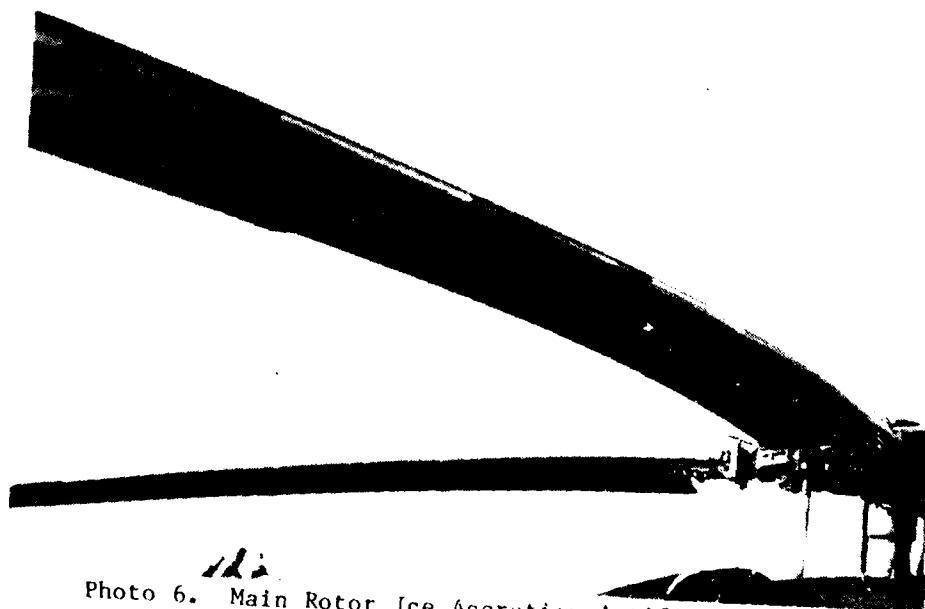
Photo 6. Main Rotor Ice Accretion Artificial Icing:  
 $0.21 \text{ gm/m}^3$  LWC,  $-17.0^\circ \text{ C}$ , 45 Minutes

Photo 7. Main Rotor Ice Accretion Artificial Icing:  
0.21 gm/m<sup>3</sup> LWC, -17.0°C, 45 Minutes

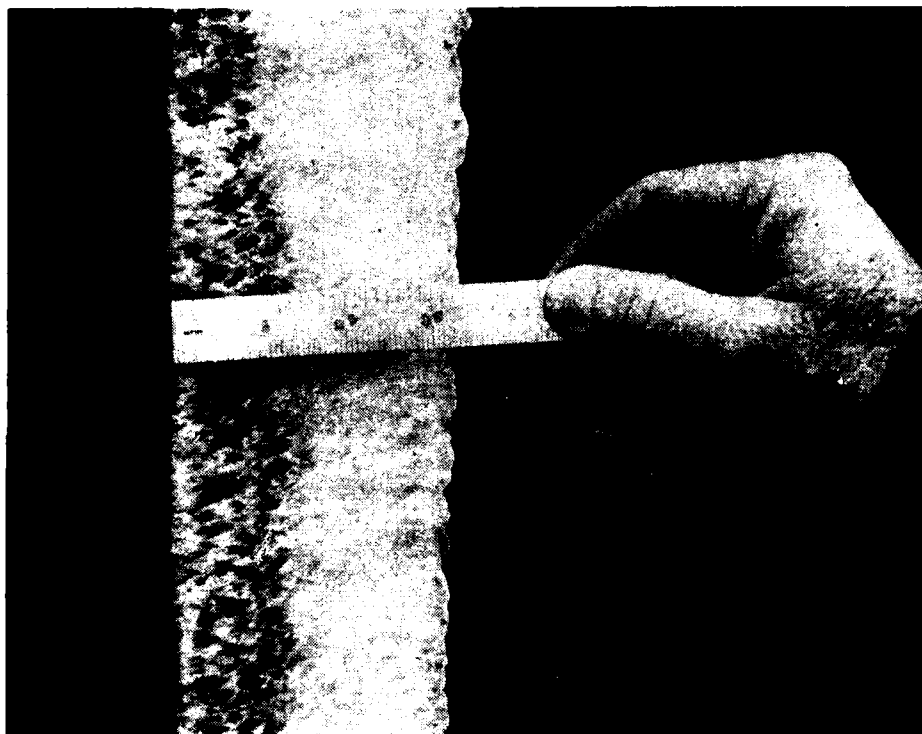
Photo 11. Ice Accretion on FM Antenna Natural Icing:  
0.42 gm/m<sup>3</sup>, -7.0° C, 95 Minutes

Photo 12. Ice Accretion on FM Antenna Natural Icing:  
0.42 gm/m<sup>3</sup> LWC, -7.0° C, 95 Minutes

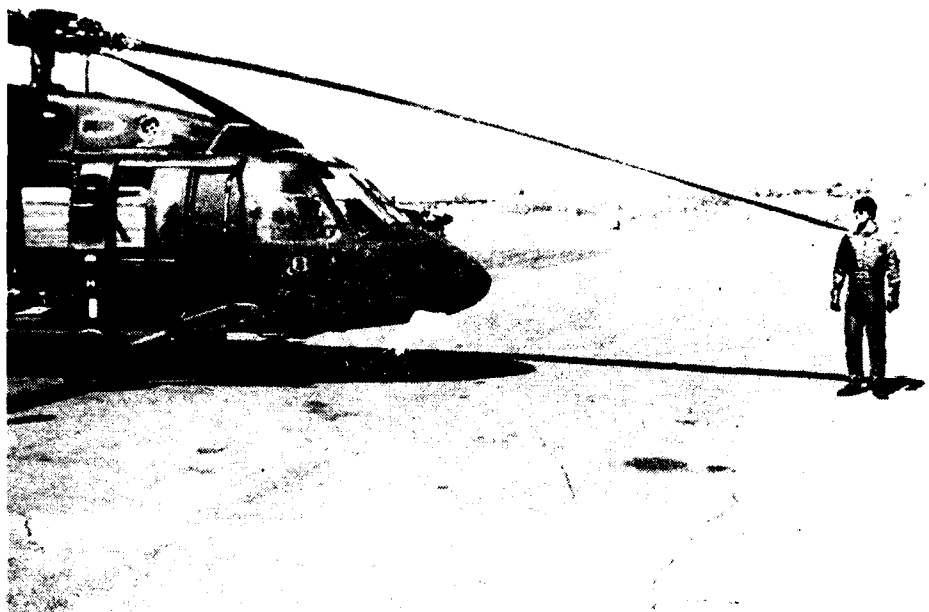
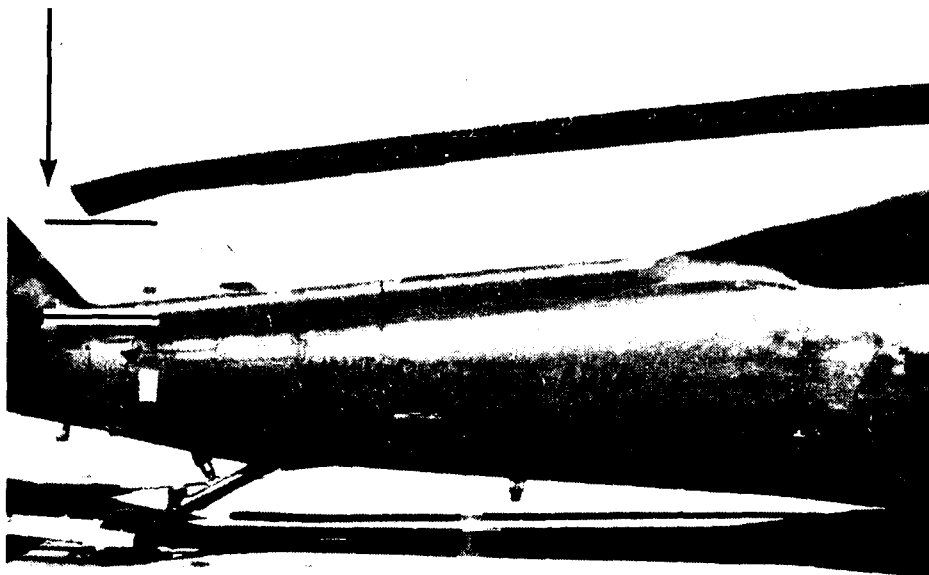
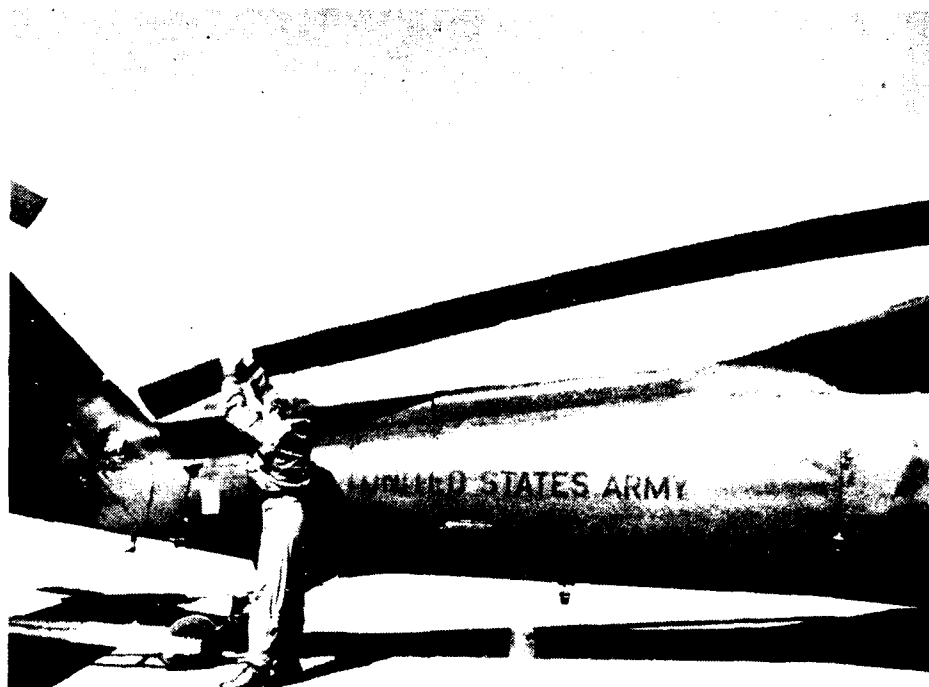
or gusty wind conditions the main rotor blades may strike the tail rotor drive shaft in the vicinity of the tail rotor intermediate gear box. Photos 13 through 15, appendix G show the static position of a main rotor blade with the droop stop in the "flight" position. The blade may flex more than this in high or gusty winds and cause fuselage or main rotor system damage if the flap restrainers are frozen in the "flight" position. Photos 16 and 17, appendix G show a flap restrainer in the "shutdown" position and frozen in the "flight" position, respectively. This situation occurred after an artificial icing encounter of 60 minutes at  $0.49 \text{ gm/m}^3$  LWC and  $-6.0^\circ \text{C}$ . The unheated GCT droop stops functioned properly at all icing conditions tested with  $0.3 \text{ gm/m}^3$  LWC or less. At all conditions tested with LWCs greater than  $0.3 \text{ gm/m}^3$  the potential exists for improper positioning of the droop stops and flap restrainers during shutdown. The production droop stops (P/N 70105-08151-041) demonstrated poorer ice accretion characteristics than did the GCT droop stops (ref 4, app A); therefore, improper droop stop positions may occur at LWCs less than  $0.3 \text{ gm/m}^3$ . Incorrect GCT droop stop position during shutdown could cause main rotor/fuselage contact and is a deficiency.

Photo 13. Droop Stop in the "Fly" (Incorrect) Position

Photo 14. Droop Stop in the "Fly" (Incorrect) Position

Photo 15. Droop Stop in the "Fly" (Incorrect) Position

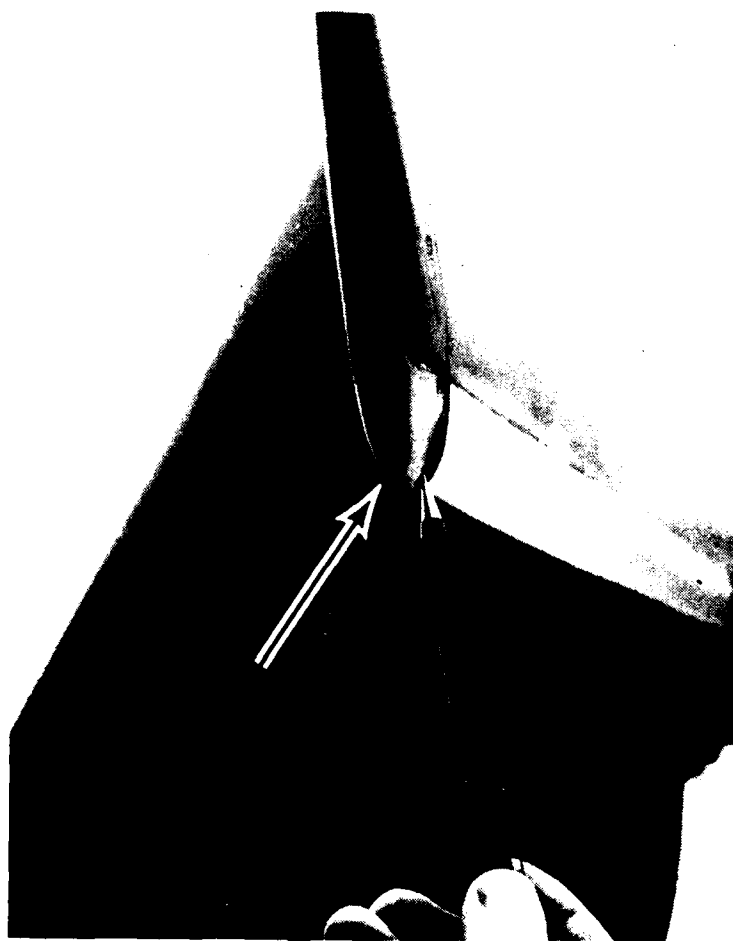
16. The aircraft sustained damage during flights under both artificial and natural icing conditions. During an artificial icing flight at  $0.49 \text{ gm/m}^3$  LWC and  $-6.0^\circ \text{C}$  a tail rotor blade tip cap was damaged, requiring replacement (photo 18, app G). During another artificial icing flight at  $0.5 \text{ gm/m}^3$  LWC and  $-12.5^\circ \text{C}$ , several components were damaged. The white strobe portion of the upper anti-collision light was broken (photo 19, app G) by ice shed from the main rotor. The shattering glass from the anti-collision light was thrown into the tail rotor blades causing damage to the leading edge of all four blades. Additionally, the tail rotor gear box fiberglass cowling was hit by ice shed from the main rotor causing a dent approximately 9 inches in diameter and 4 inches deep. The cowling was split approximately 6 inches (photos 20 and 21, app G).

Photo 18. Damaged Tail Rotor Tip Cap Artificial Icing:  
0.49 gm/m<sup>3</sup> LWC, -6.0° C, 60 Minutes

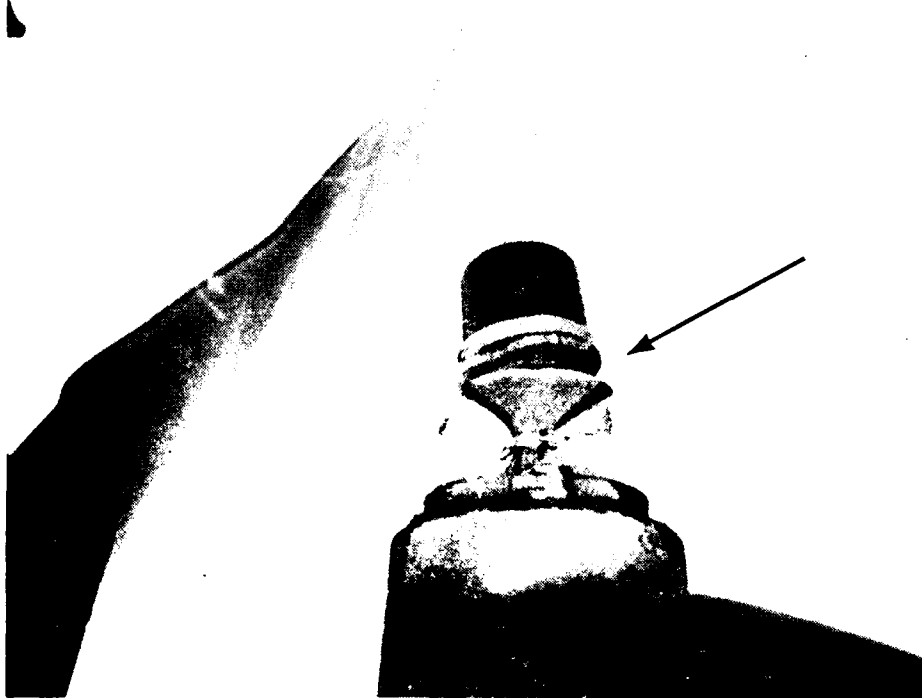
Photo 19. Broken Upper Anti-Collision Light Artificial Icing:  
 $0.5 \text{ gm/m}^3$  LWC,  $-12.5^\circ \text{ C}$ , 81 Minutes

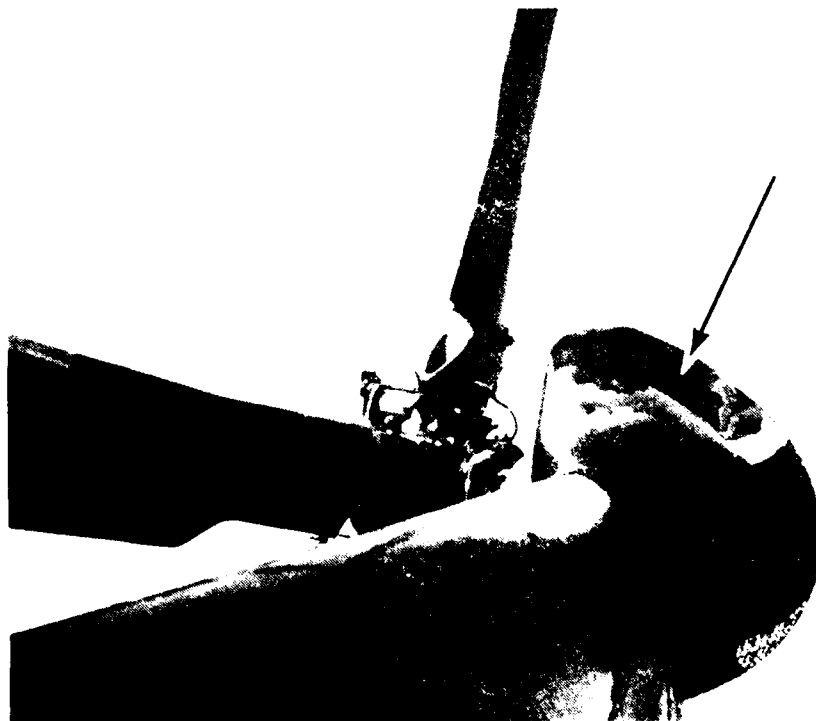
Photo 20. Damaged Tail Rotor Gearbox Cowling Artificial Icing:  
 $0.5 \text{ gm/m}^3$  LWC,  $-12.5^\circ \text{ C}$ , 81 Minutes

Photo 21. Damaged Tail Rotor Gearbox Cowling Artificial Icing:  
0.5 gm/m<sup>3</sup> LWC, -12.5°C, 81 Minutes

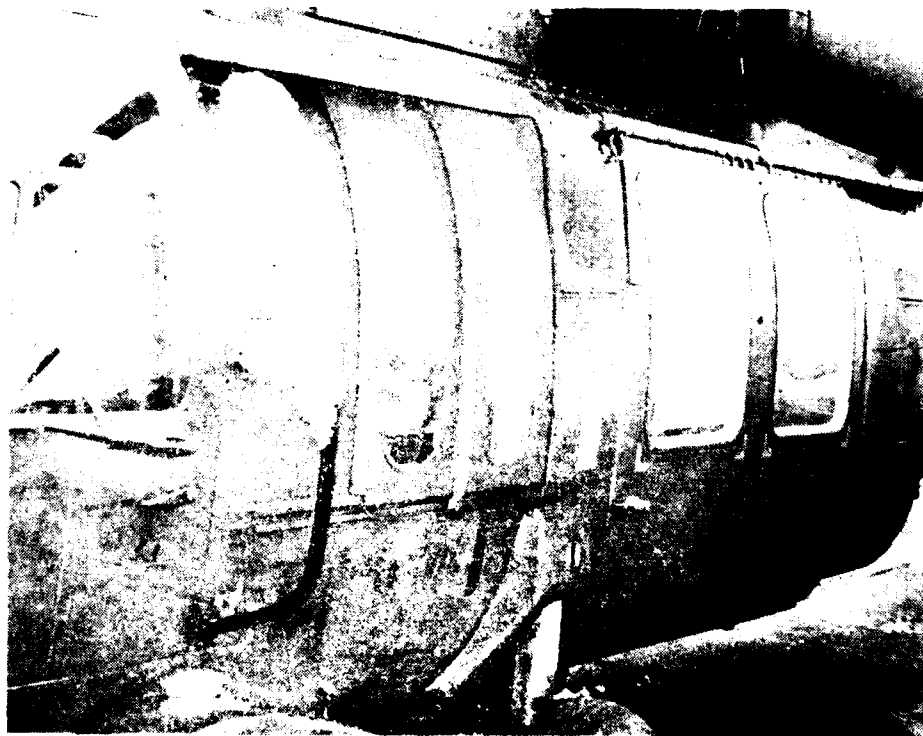
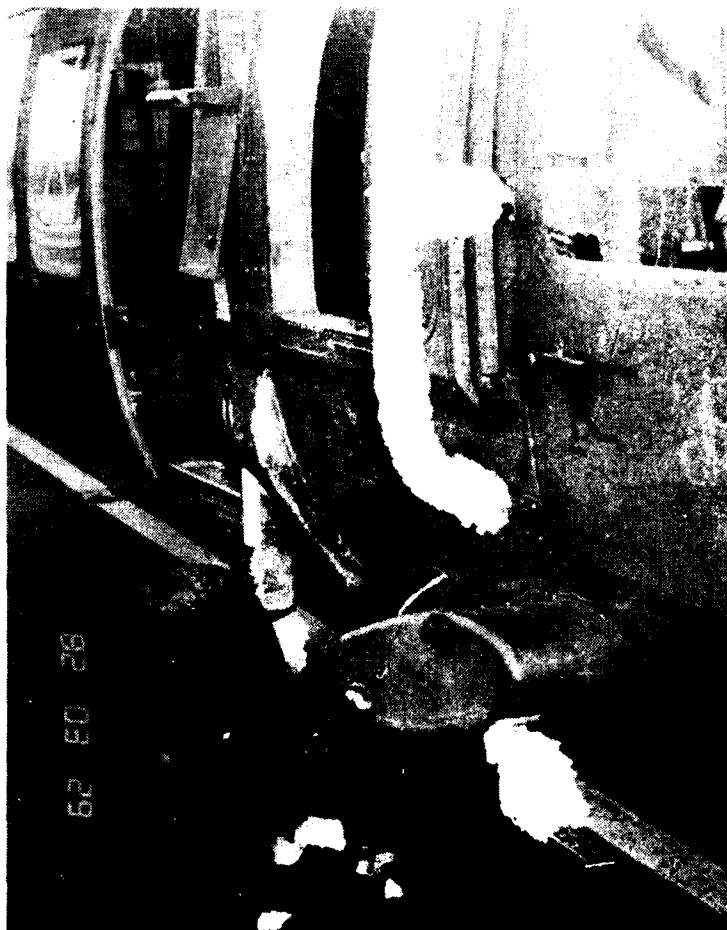
Photo 22. Ice Accretion on FM Antenna Natural Icing:  
0.5 gm/m<sup>3</sup> LWC, -4.0°C, 43 Minutes

23. Ice Accretion on FM Antenna Natural Icing:  
0.5 gm/m<sup>3</sup> LWC, -4.0°C, 43 Minutes
